NetClock version 3.6.7 Release Notes

We at Spectracom Corporation continuously strive to improve our products. To this end, we have released a software update (Application software version 3.6.7) for the Spectracom NetClocks (Models 9383, 9389, 9283, and 9289) and the Ethernet Time Servers (Models 9388 and 9288).

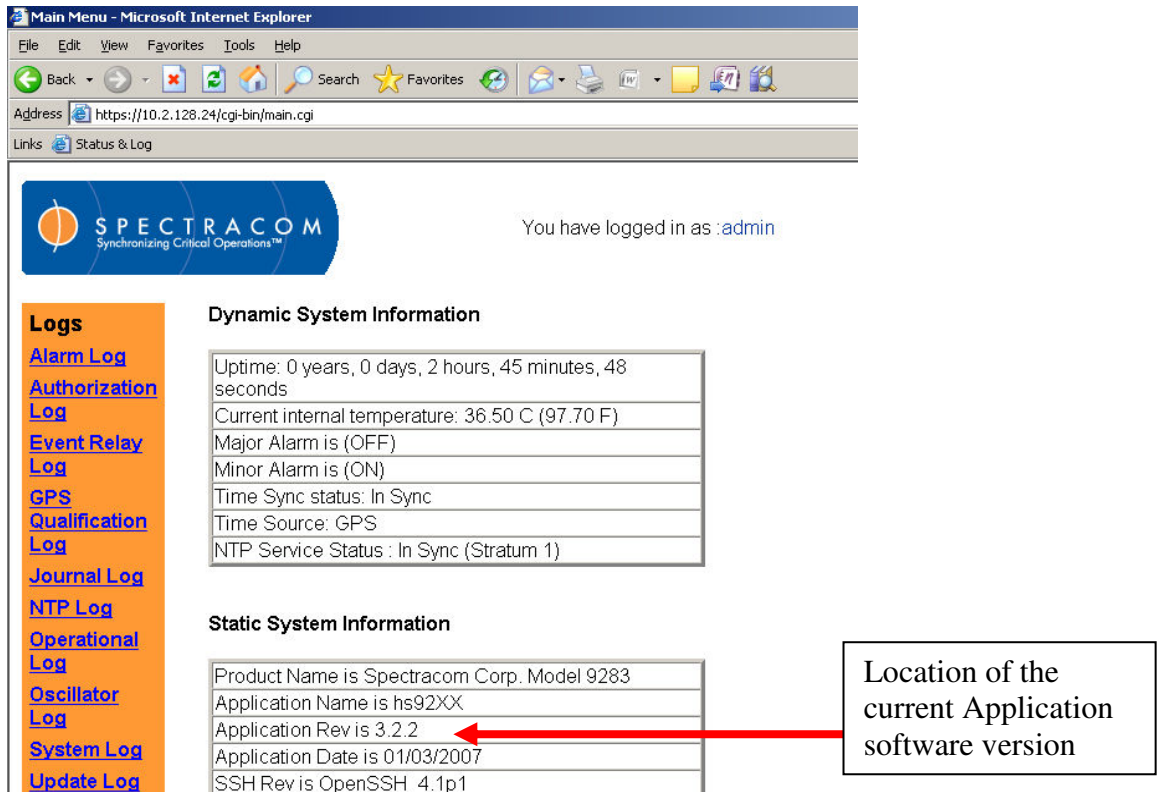
Figure 1: Application Software Revision Contained on the System Status Page

To determine the current application software version of your NetClock or Ethernet Time Server, log in to the unit's web browser user interface. Click on "Status and Logs" located on the bottom menu and then on "System Status" located on the left menu. Scroll down to the "Static System Information" box, which contains a line stating "Application Rev is." The number next to this is the current Application software version. Refer to Figure 1.
